SAINT CROIX RIVER BASIN  
Baileyville, Maine, United States and St. Stephen, New Brunswick, Canada

## **WOODLAND DAM ME 00218**

### **PHASE I INSPECTION REPORT NATIONAL DAM INSPECTION PROGRAM**

SEPTEMBER 1981

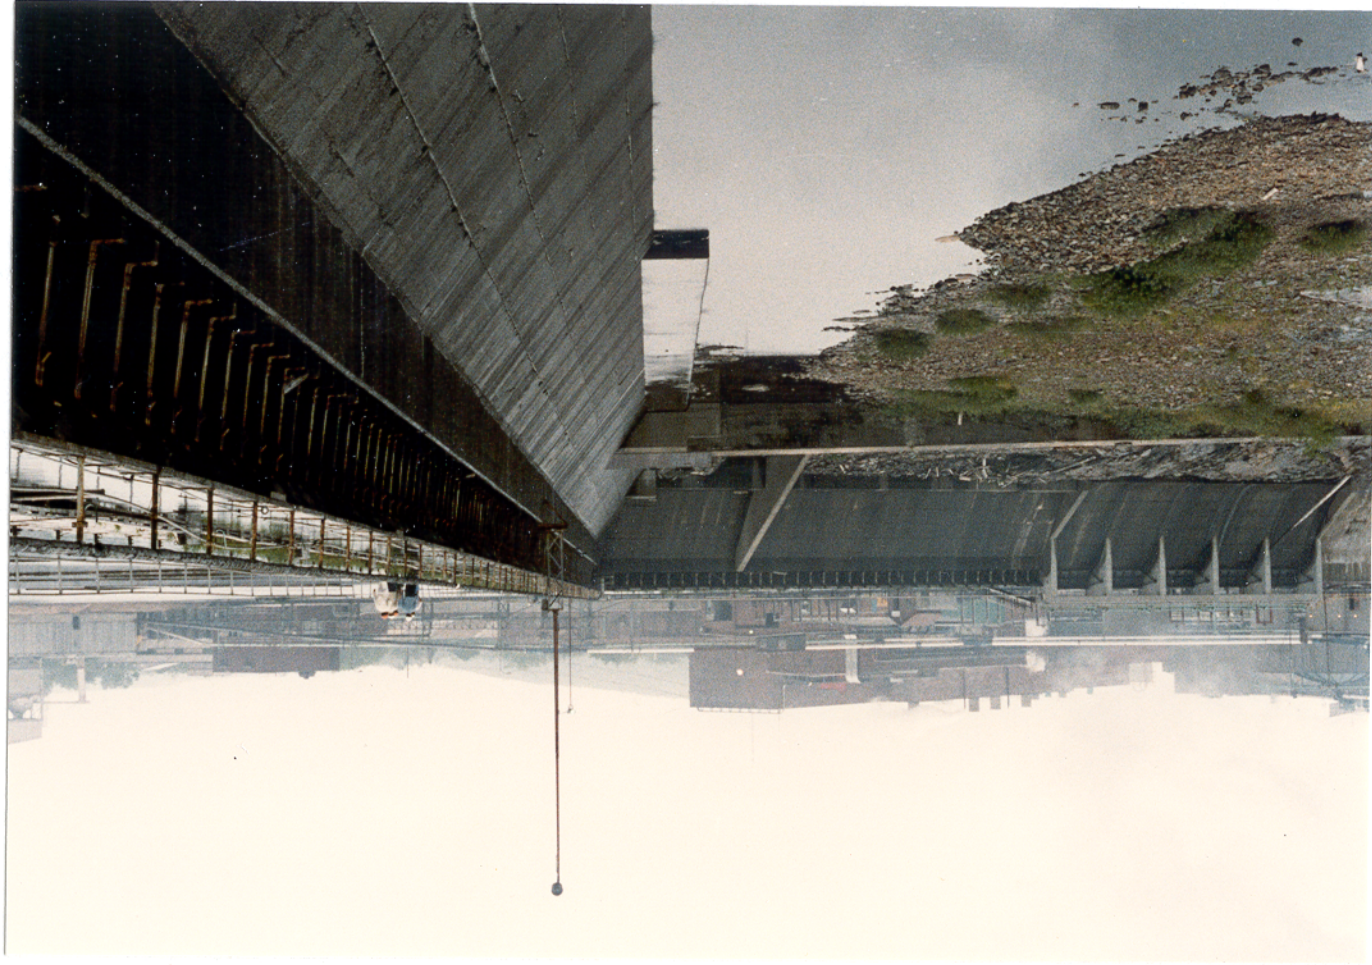
1. Overview of dam from left abutment

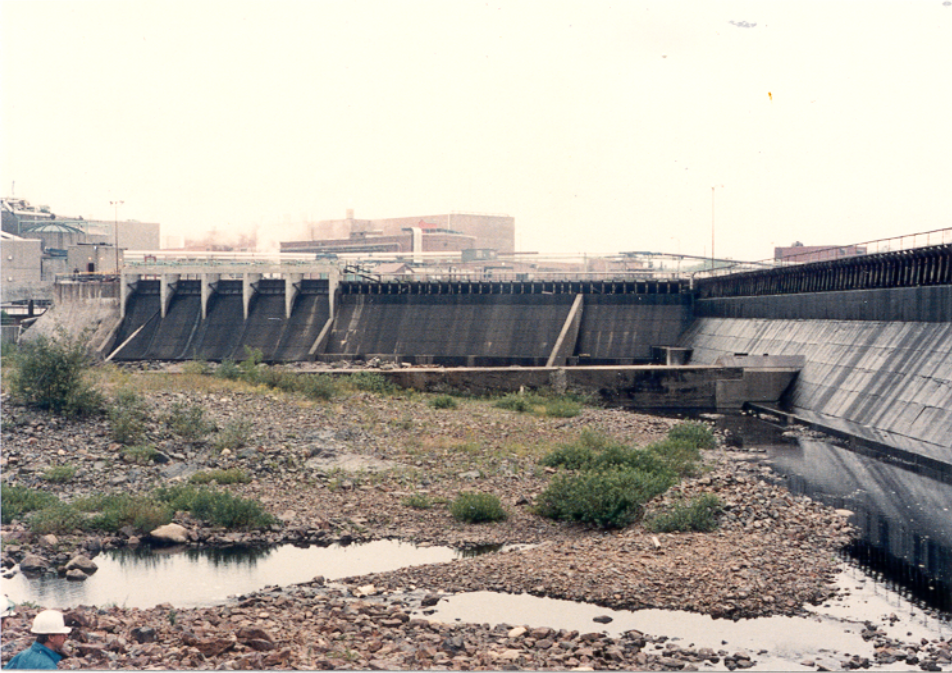
- c. Appurtenant Structures - The two sections of the emergency spillway and the principal spillway are in good condition. There is minor spalling at the construction joints and several minor longitudinal surface cracks 1/4" - 1/2" wide and up to 25 to 30 feet long on the downstream faces of each of the structures.

No. 2  
Downstream face of  
Canadian spillway  
from left abutment  
area.

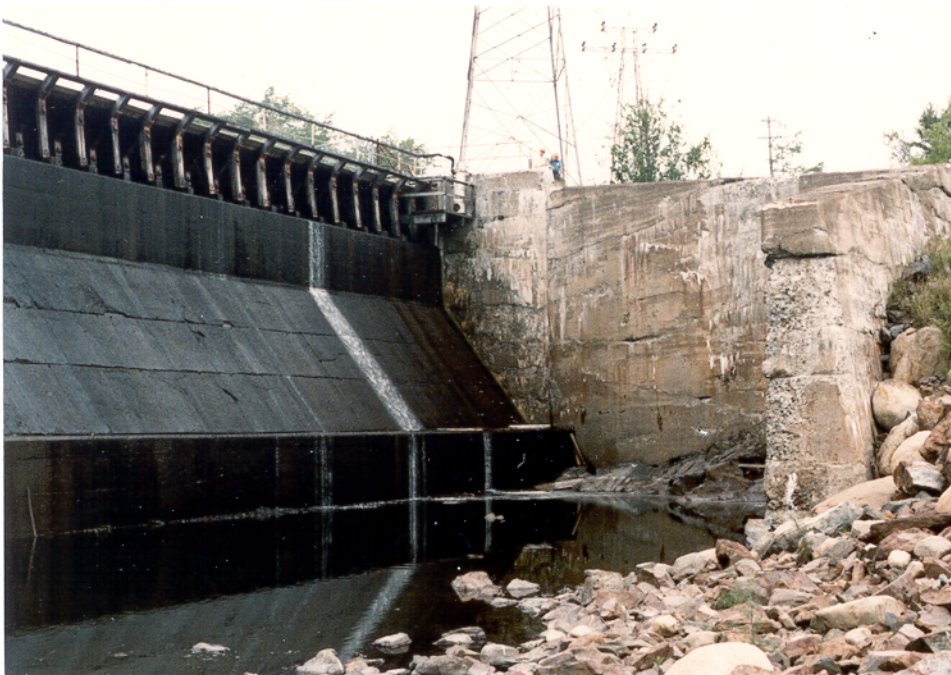
Downstream of the left abutment is a guide wall (Photo 3) which is in fair condition. There are a number of longitudinal cracks up to 1/2" wide and 35 feet in length along the entire wall. Several spalled areas up to 2-3" in depth were also noted.

No. 3  
Left abutment from  
downstream.

- a. Investigate the integrity of the hydraulic wall, headworks and adjacent wingwall and guide wall downstream of the left abutment. Based upon this investigation design and supervise implementation of the recommended repair schemes for each structure.
- b. Prepare a set of complete drawings on the site noting all civil structural dimensions including NGVD elevations, and all mechanical and electrical aspects of the project.
- c. Investigate the sedimentation at the upstream face of the structure and supervise implementation of the recommendations of the investigation.
- d. The floating walkway is inadequate for current operating procedures for safety of personnel. It is recommended that a more permanent alternate means of access to remove the flashboards (i.e., a catwalk) be investigated. Based upon this investigation, design and supervise implementation of the recommended alternative.

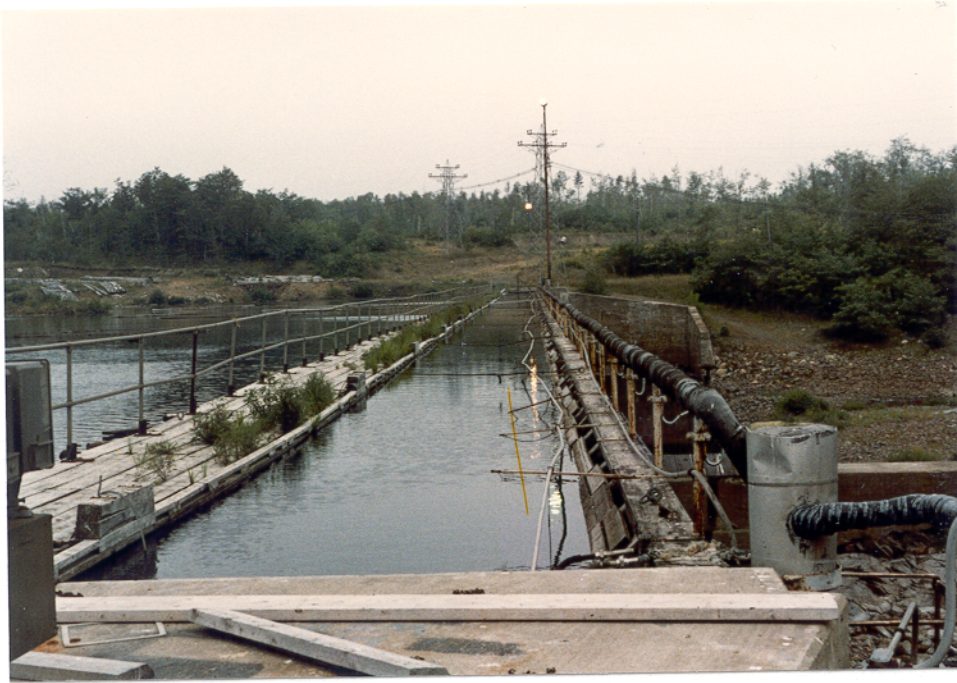
No. 4  
View Across crest  
of Canadian spillway  
from corner pier.

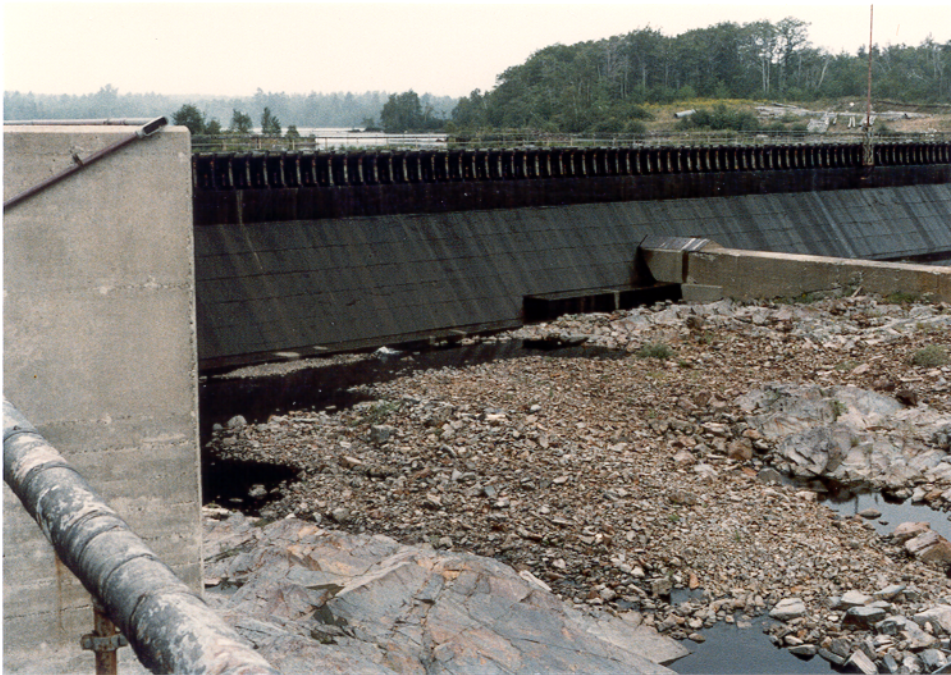
No. 5  
Downstream slope of  
Canadian spillway  
from dam crest at  
the fishway.

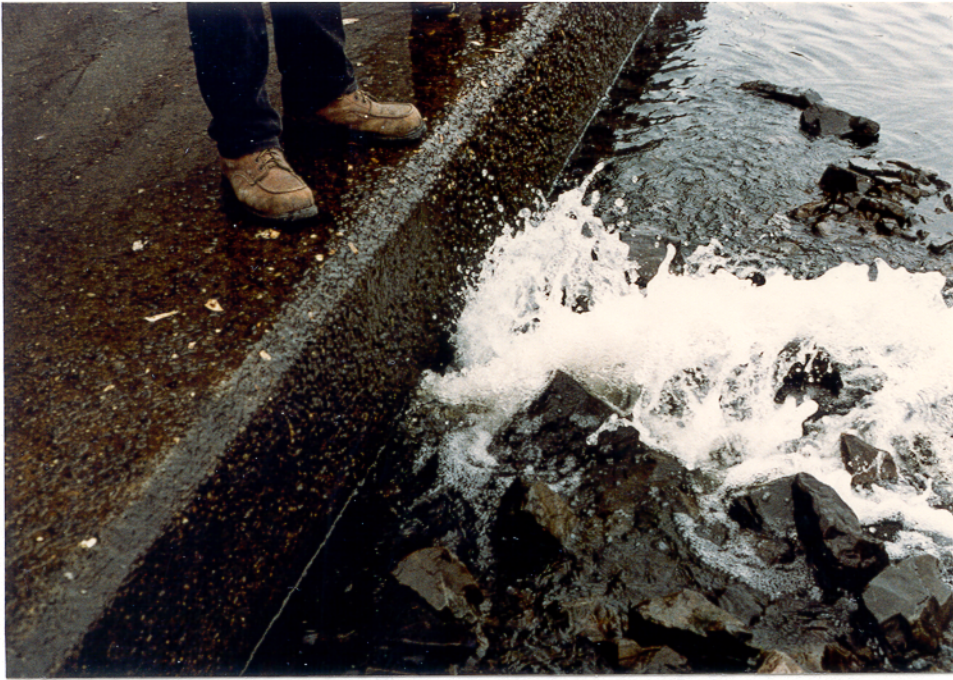
Flow was observed at the downstream toe of the emergency spillway (See Photo 6) about 150 feet left of the corner pier. It was reported that the flow was from a 4-6" PVC pipe which was embedded in an old mud gate at the time of the '72 rehabilitation of the spillway. The training wall at the downstream toe is in an advanced state of deterioration with extensive cracking and spalling of the concrete. At the toe, the wall has been capped with a steel plate to protect it from damage due to ice falling over the crest.

No. 6  
Flow at downstream  
toe of Canadian  
spillway.

- e. Design and supervise construction of a low level outlet or an alternative means of dewatering the reservoir.
- f. Investigate the flow from the 4-6" PVC pipe at the downstream toe of the spillway and design and supervise implementation of any recommended repairs. Until the investigation is initiated monitor the flow daily. If the amount or color of the flow changes initiate the investigation immediately.

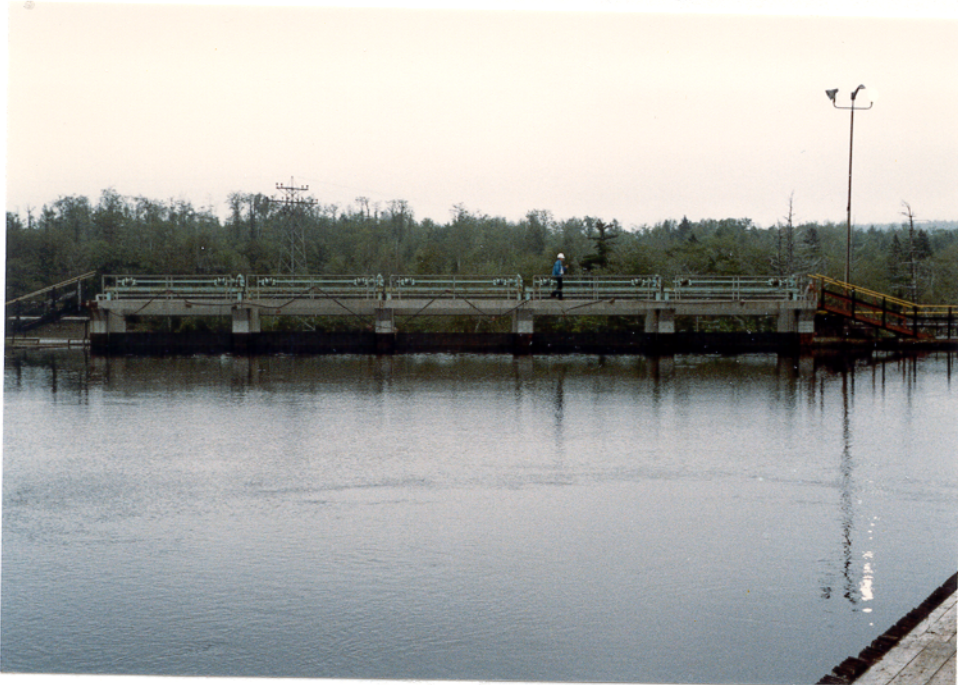
The tainter gates are experiencing minor rusting and leakage at the base. Operation of the gates was not demonstrated, however reportedly they were operated in the recent past.

No. 7  
View of tainter gates  
from the headworks.

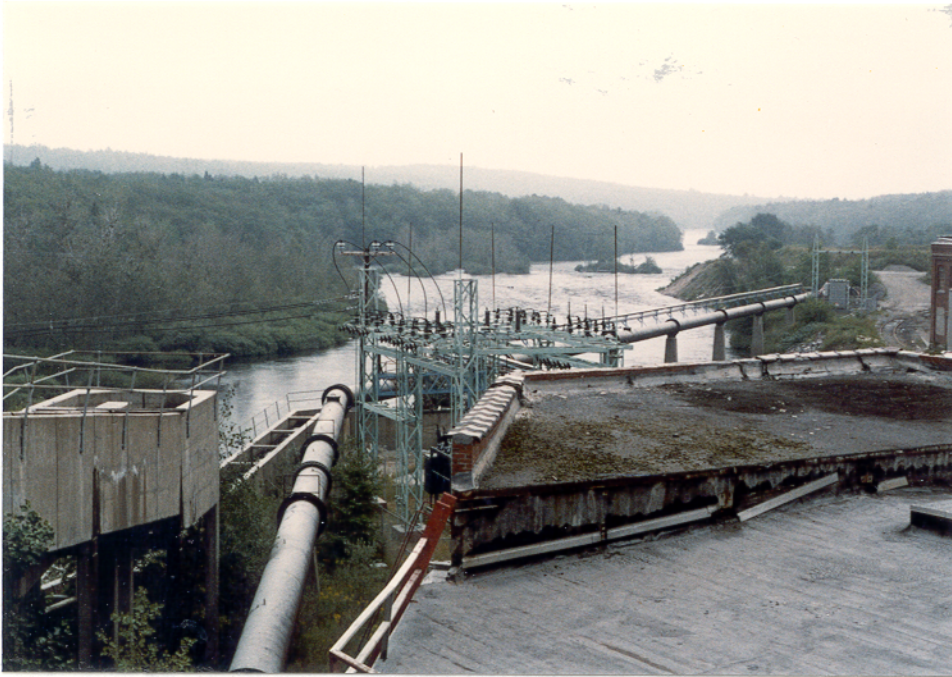
The fishway and the 42" Ø penstock are each in good condition (See Photo 8). In addition, the control gates for each structure appeared to be in good condition. Neither was operated during the inspection.

No. 8  
View downstream  
from dam at the  
process water  
gatehouse.

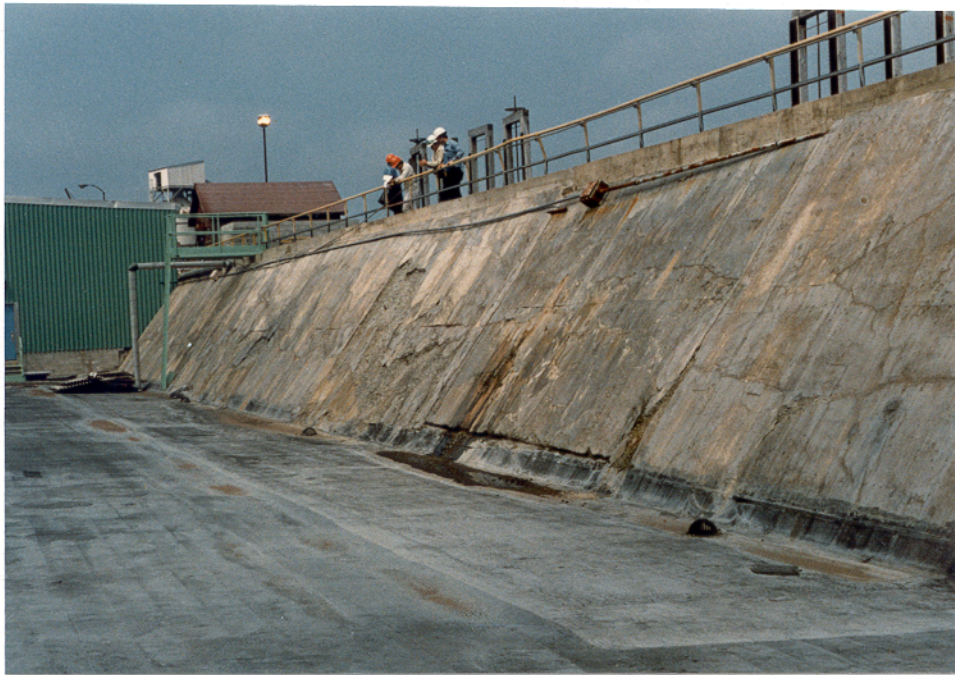
No. 10  
View of the  
headworks wall  
above the old  
grinder room.

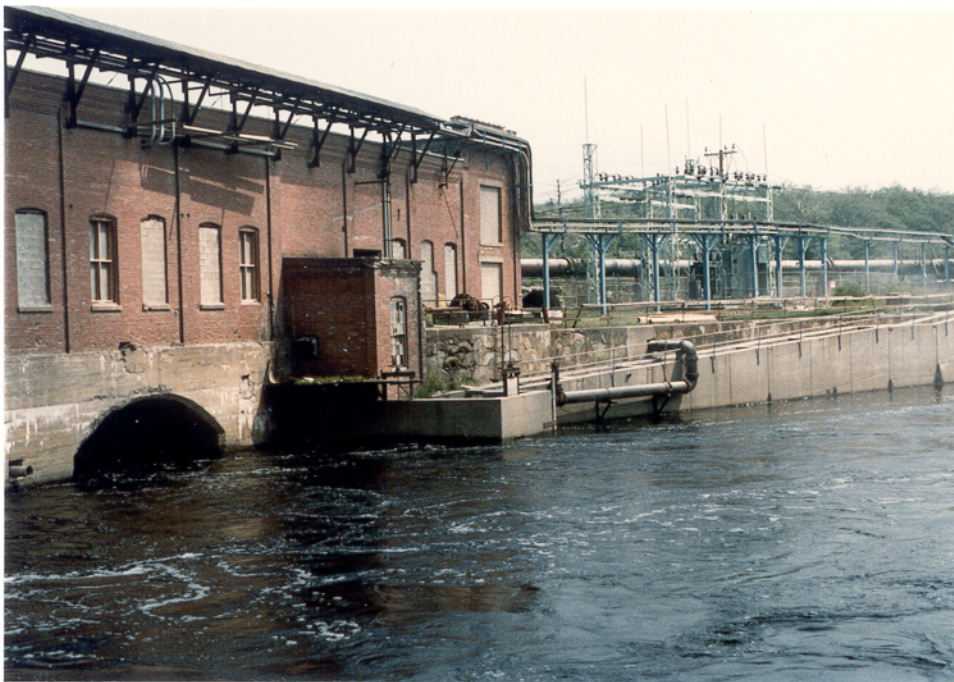
The powerhouse was in good to fair condition. The interior was visibly maintained and in good condition. The downstream wall at the tailrace was showing some signs of distress. Several small areas of spalling 1-2" in depth with some efflorescence was noted. (See Photo 11).

No. 11  
Downstream face  
of the powerhouse.

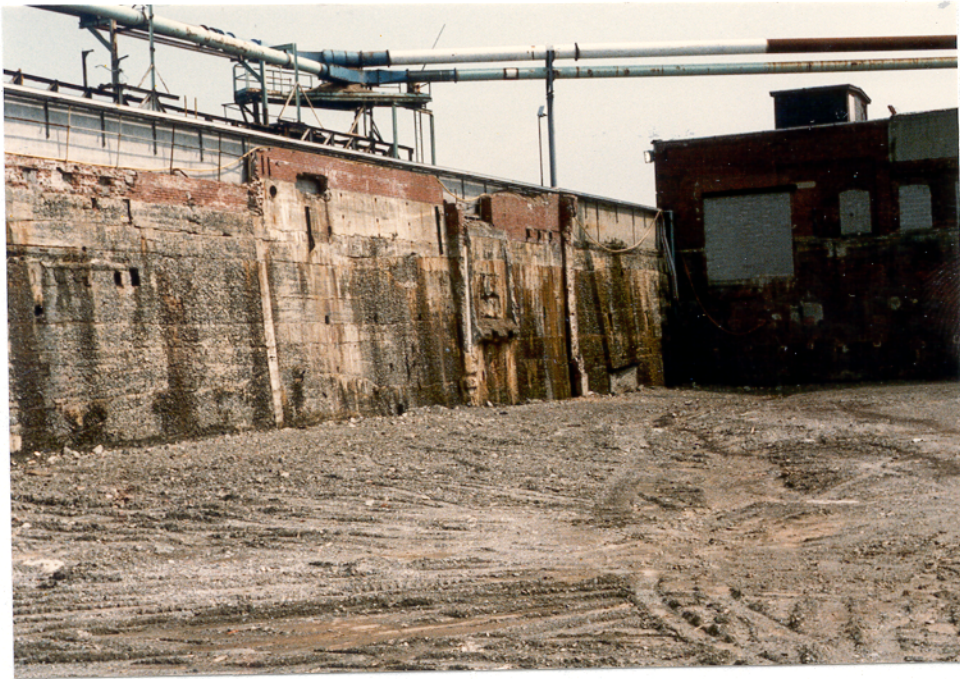
The hydraulic wall is generally in fair condition. The crest of the wall appears to have been recently repaired. The old mill downstream of the wall is presently being destroyed. Near the crest, it is difficult to distinguish between the downstream face and the old wall. (See Photos 12 and 13). Seepage was noted as a wetness along most of the old lift lines. Extensive spalling varying in depths from 1/4" to 6-8" and several longitudinal hairline cracks 40 to 50 ft. in length were also noted. Although the depth could not be determined, a buildup of sediment on the upstream face of the wall was visible from the crest.

No. 12  
Downstream face  
of the hydraulic  
wall.

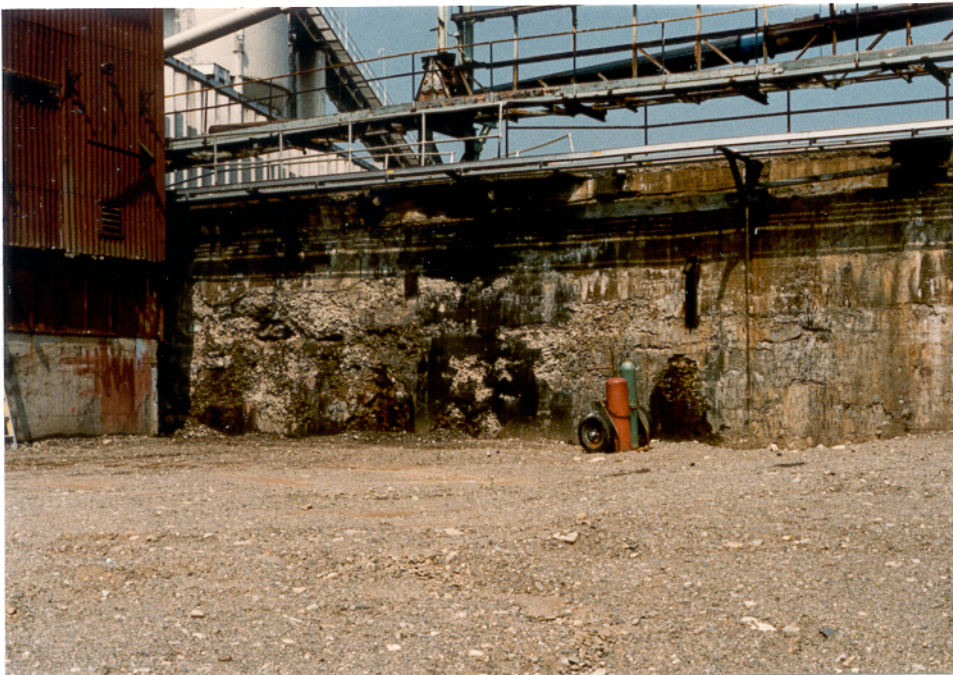
No. 13  
Downstream face  
of the hydraulic  
wall.
